| <b>Inspection Report</b> ( <input checked="" type="checkbox"/> 1 <sup>ST</sup> <input type="checkbox"/> 2 <sup>ND</sup> ) | | <b>PENDING</b> | |
| <b>Summary Section</b> | | Service Number: 20260416 | |
| | | Product Name | Drain cover |

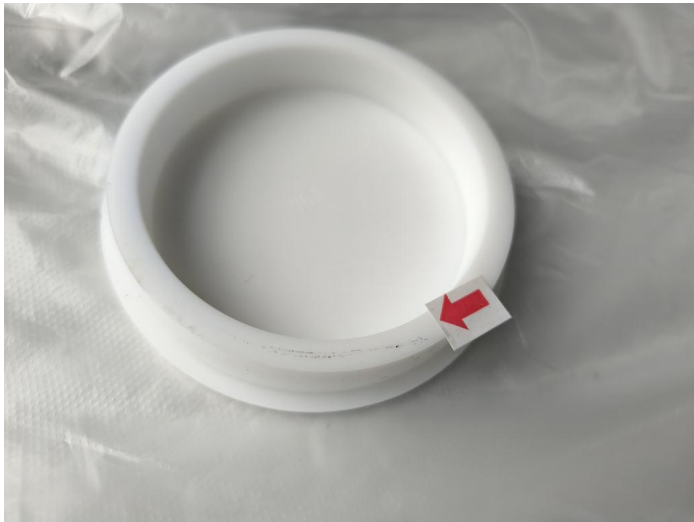
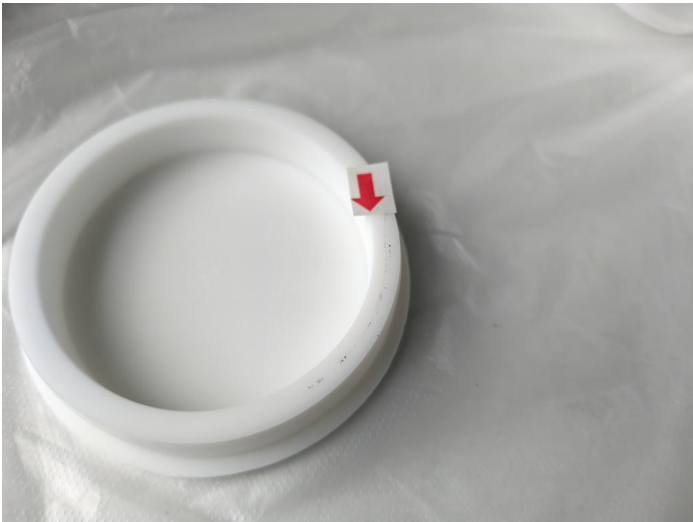
| Defectives List | | | | |
|---|---|---|---|---|
| 1. | Dirty mark | 0 | 0 | 82 |

| Defectives PIC | |
|---|---|
| Dirty mark-minor | Dirty mark-minor |

| Require factory to rework and clean off all products on site. | |

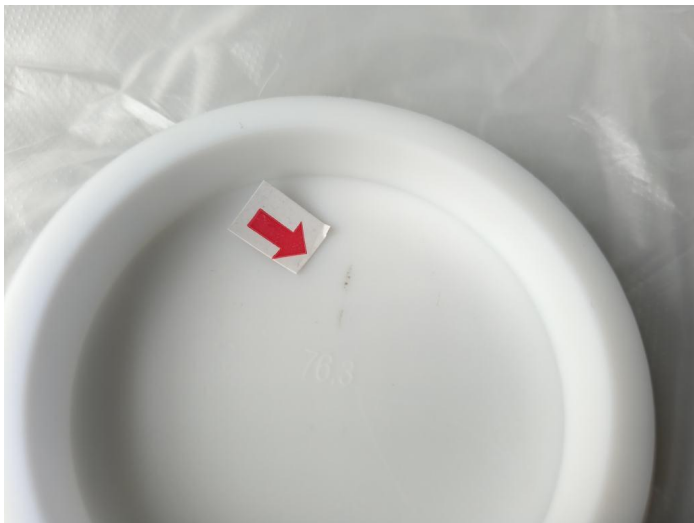
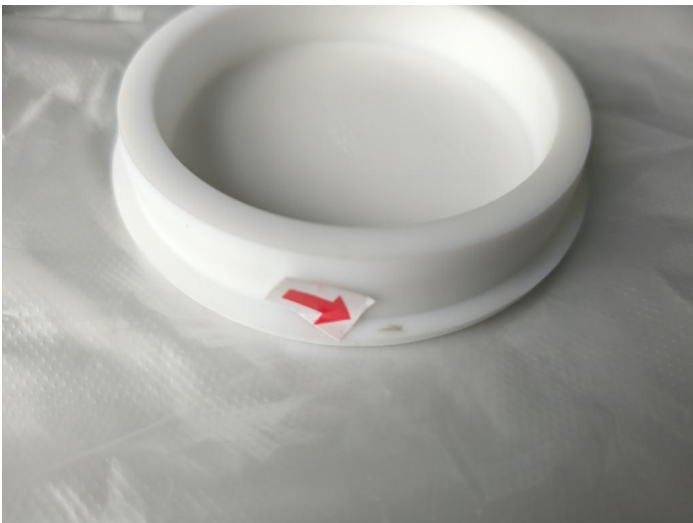
| Defectives PIC | |
|---|---|
| Dirty mark-minor | Dirty mark-minor |

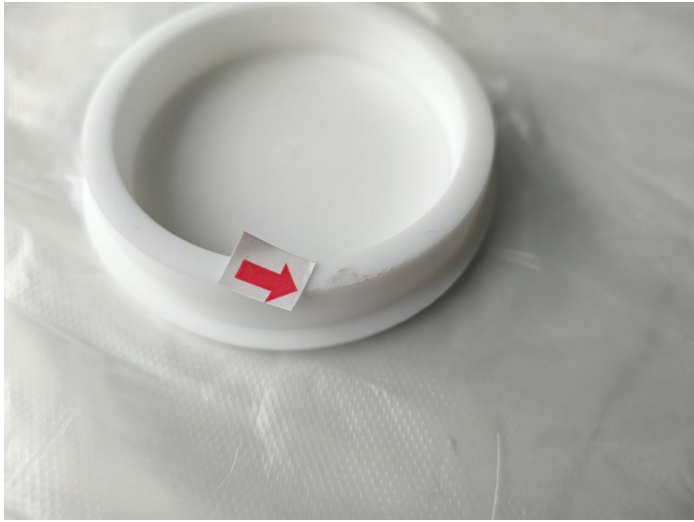
Dirty mark-minor

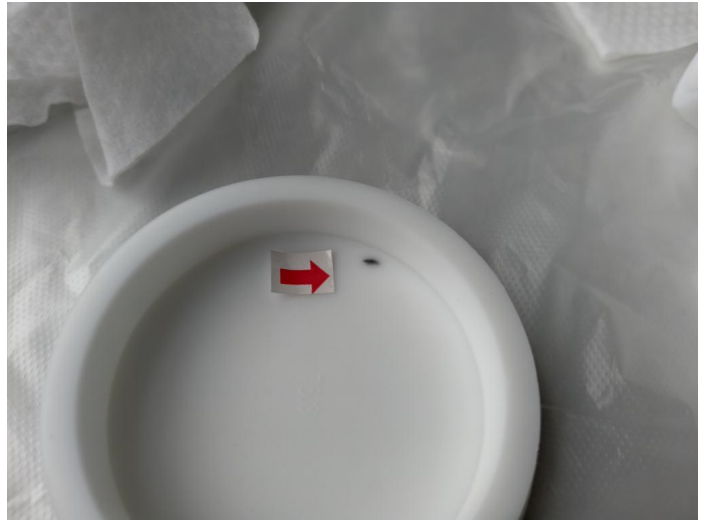
Dirty mark-minor

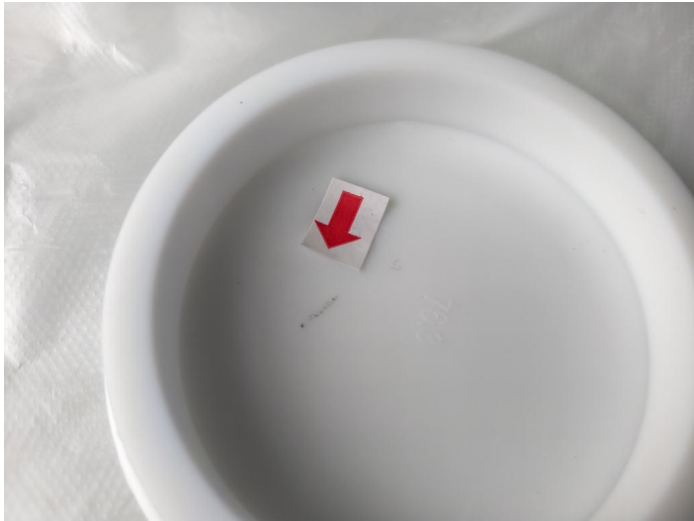
Dirty mark-minor

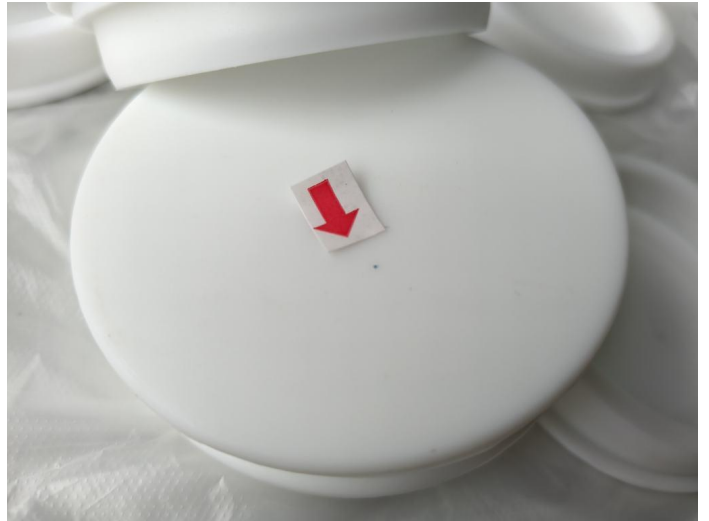
Dirty mark-minor

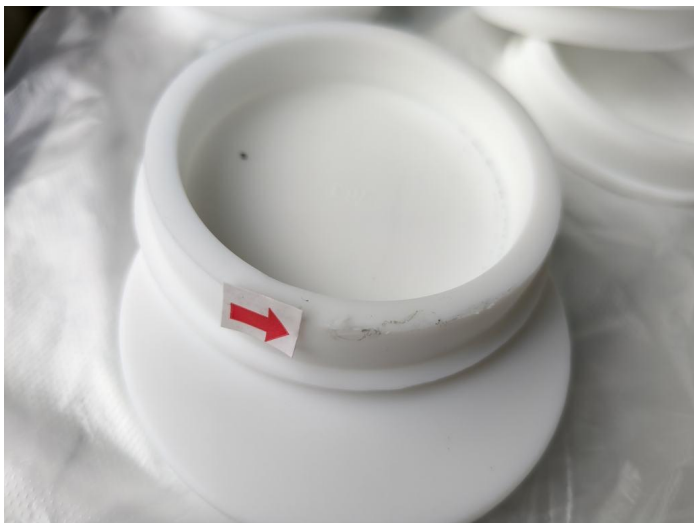
Dirty mark-minor

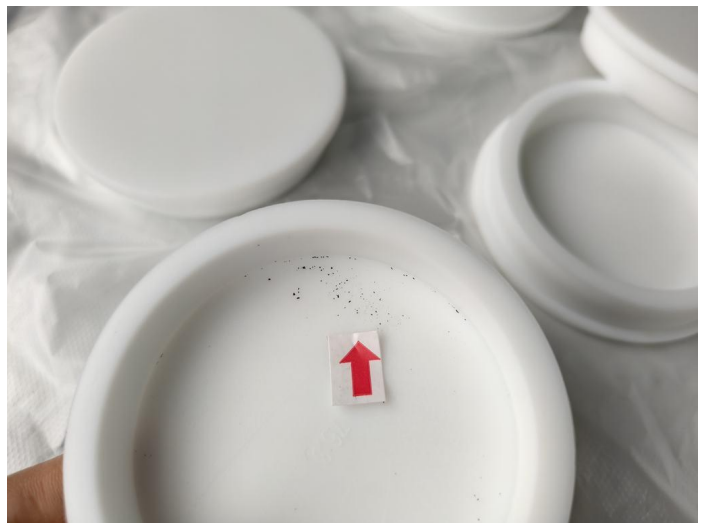
Dirty mark-minor

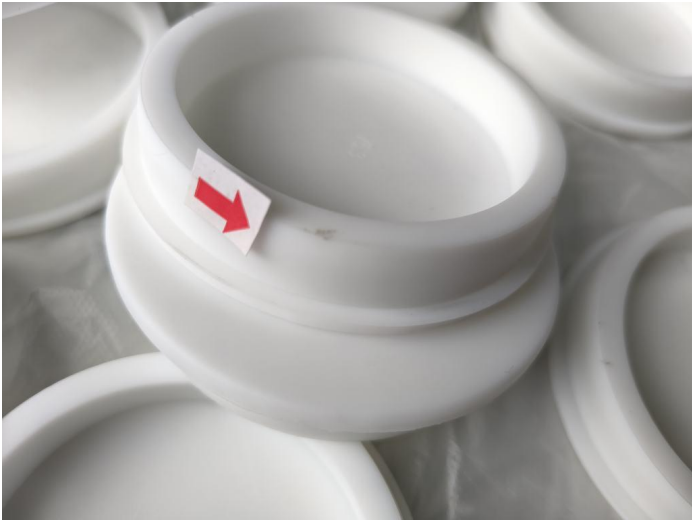
Dirty mark-minor

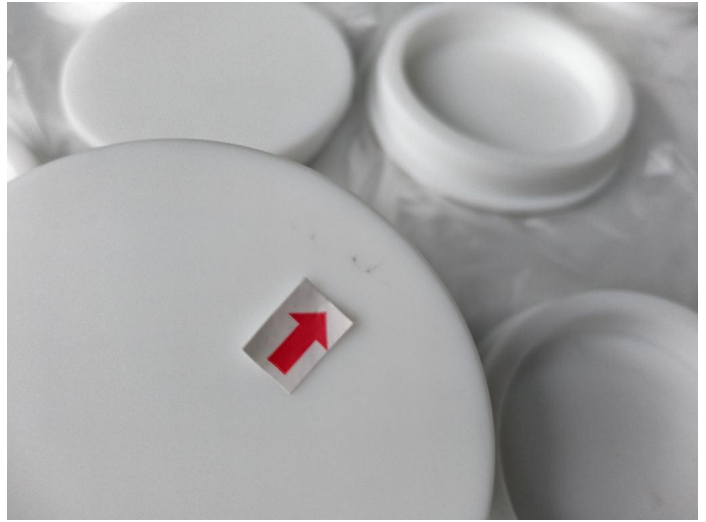
Dirty mark-minor

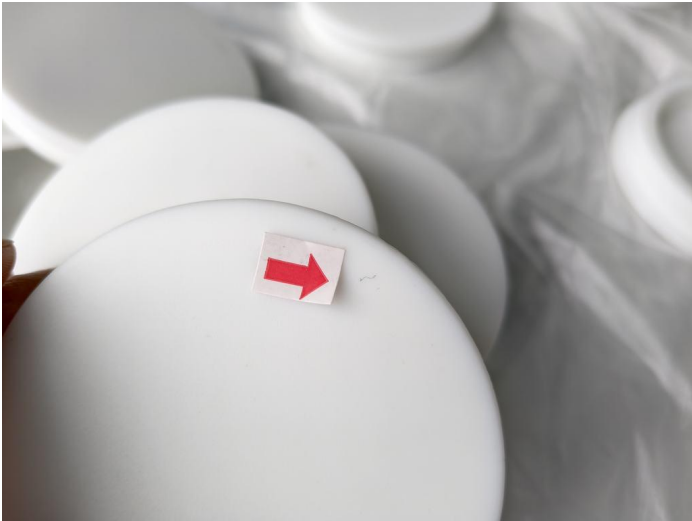
Dirty mark-minor

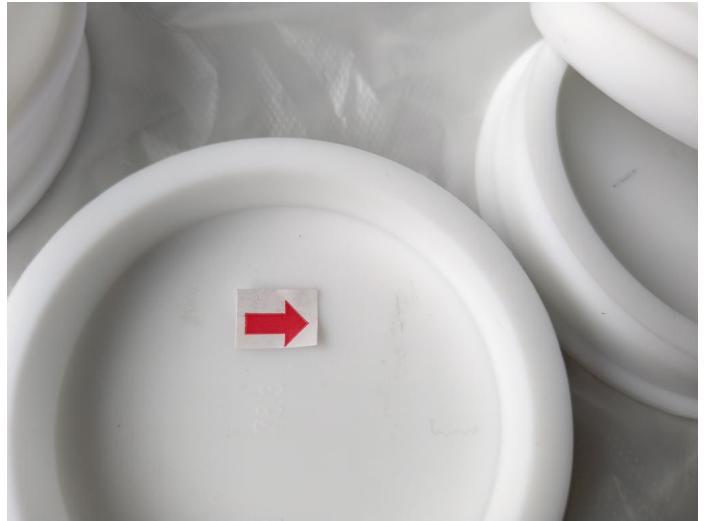
Dirty mark-minor

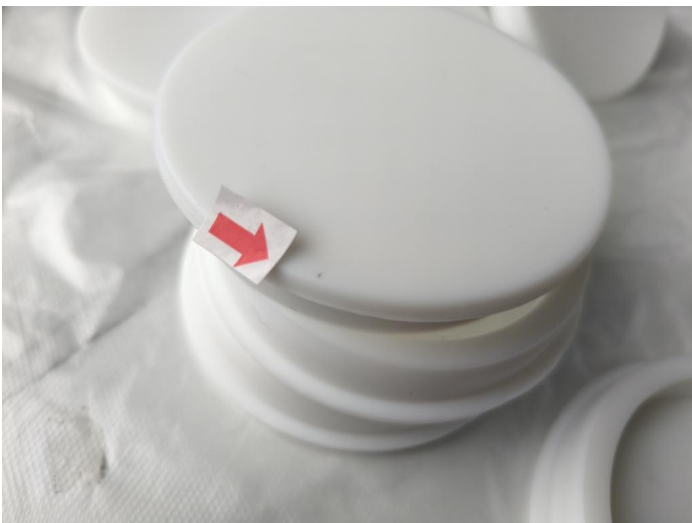
Dirty mark-minor

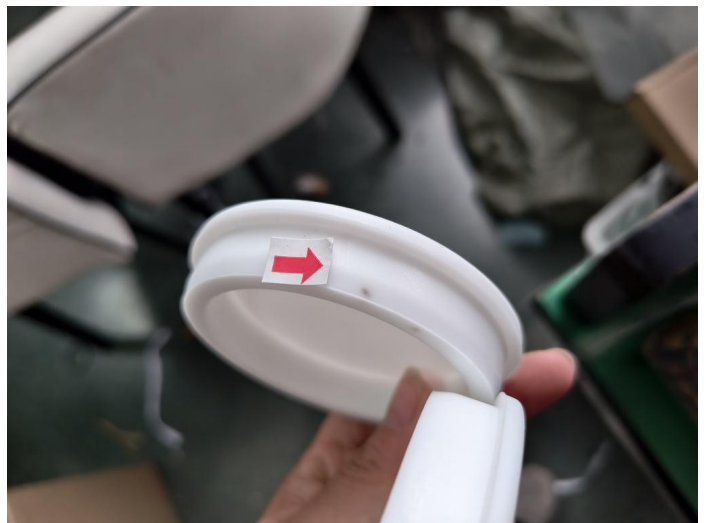
Dirty mark-minor

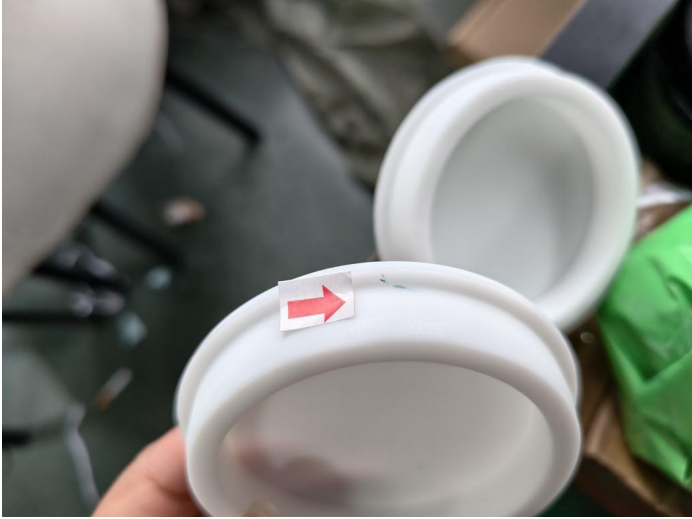
Dirty mark-minor

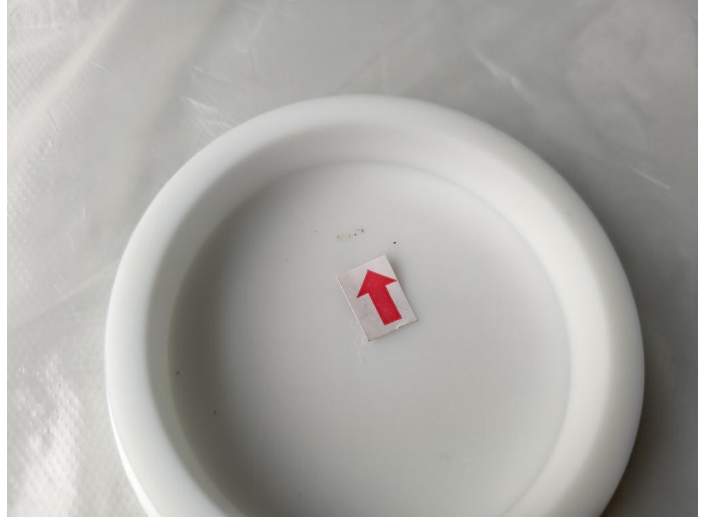
Dirty mark-minor

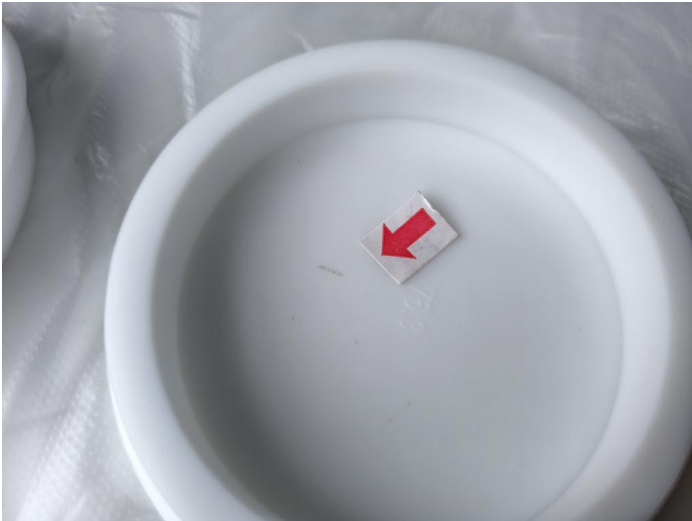
Dent mark-minor

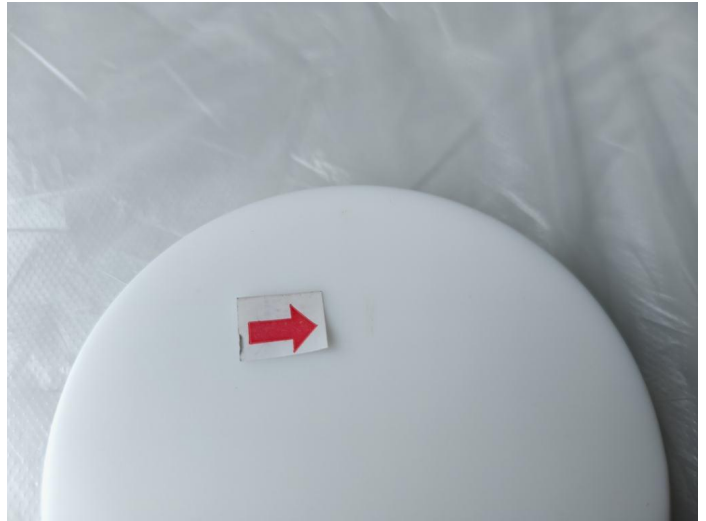
Dirty mark-minor

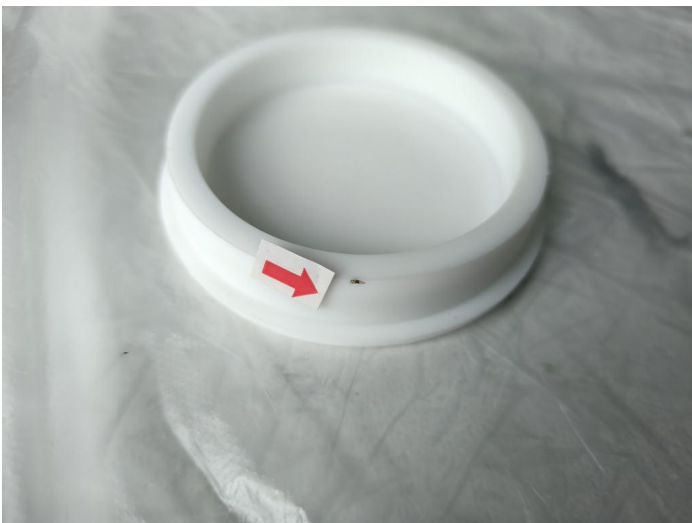
Dirty mark-minor

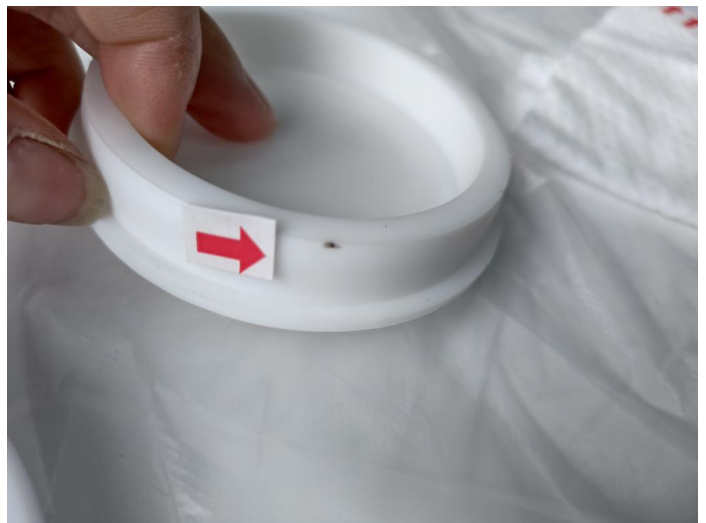
Dirty mark-minor

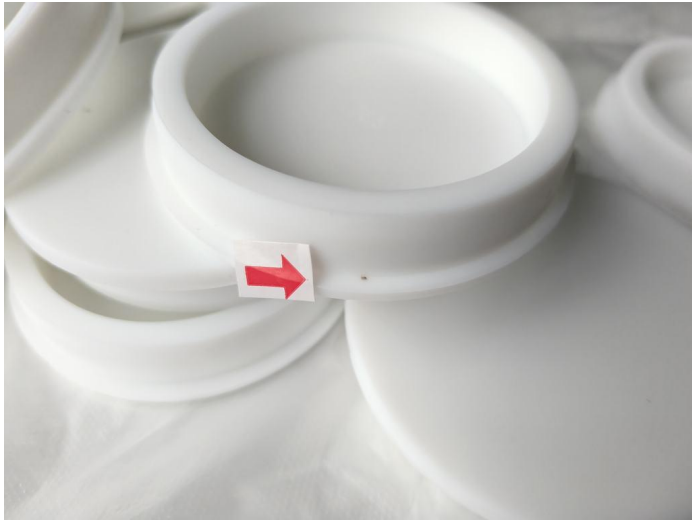
Dirty mark-minor

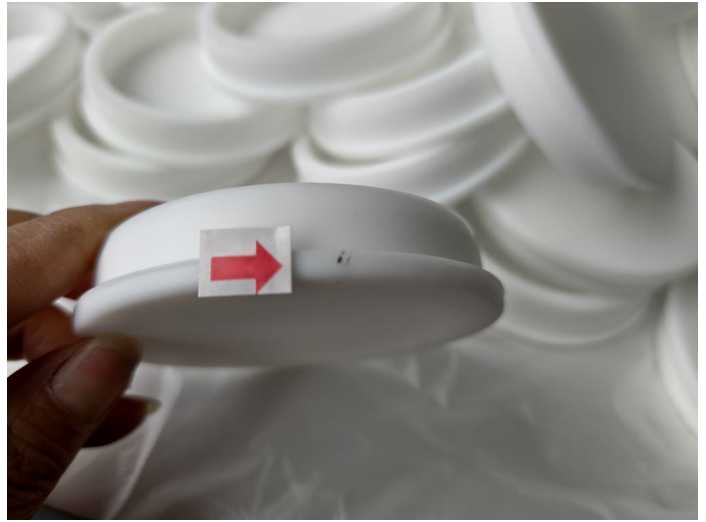
Dirty mark-minor

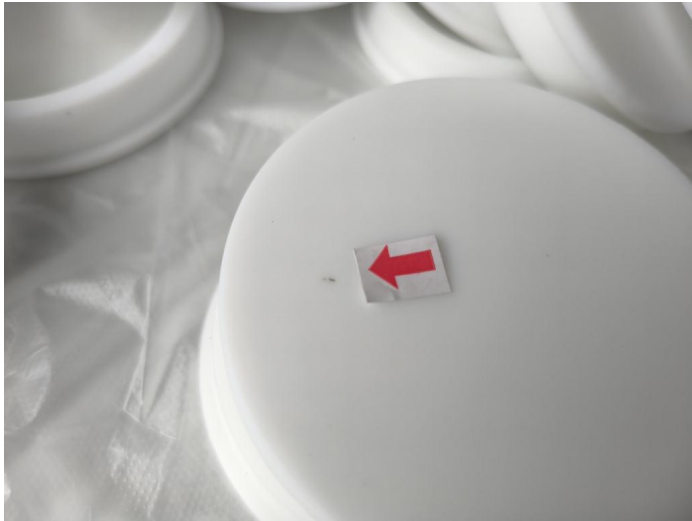
Dirty mark-minor

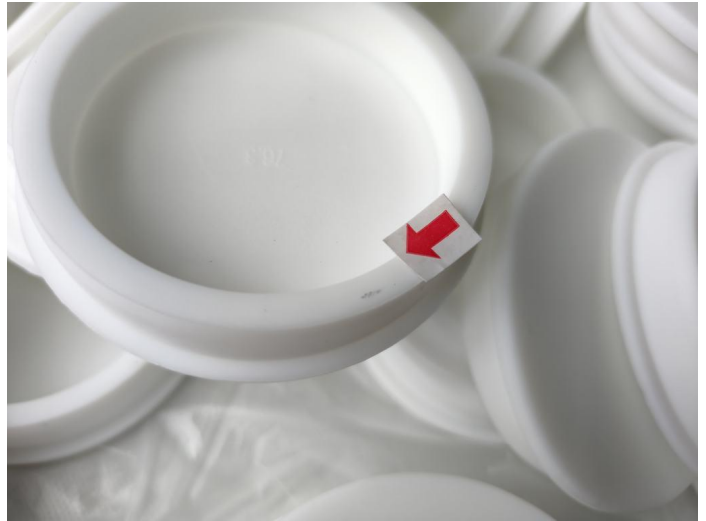
Dirty mark-minor

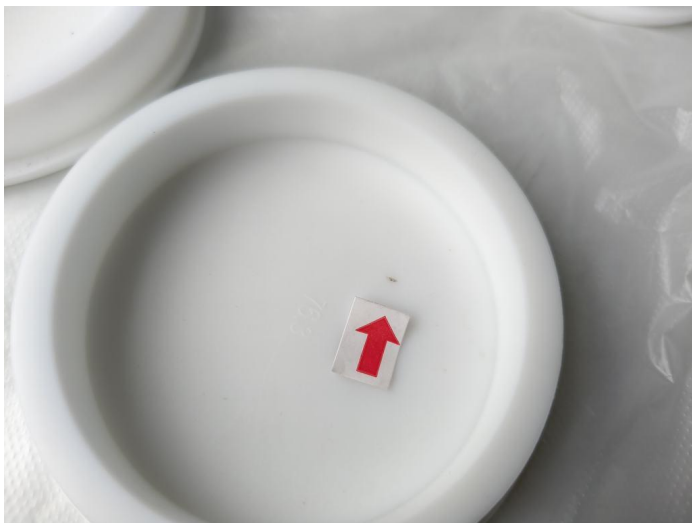
Dirty mark-minor

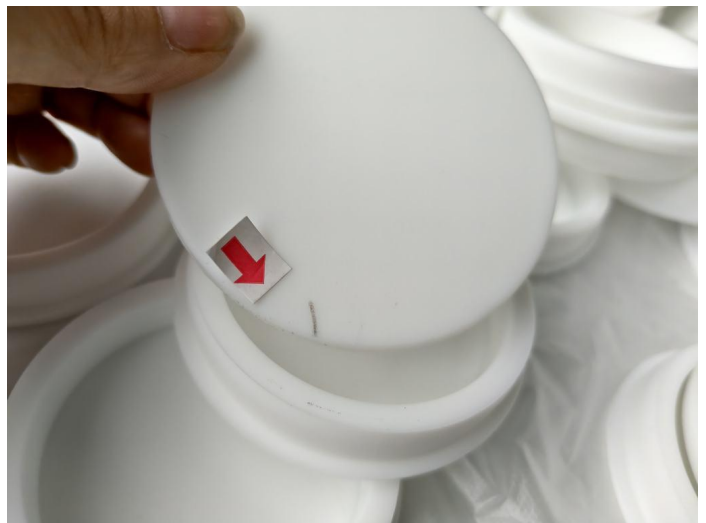
Dirty mark-minor

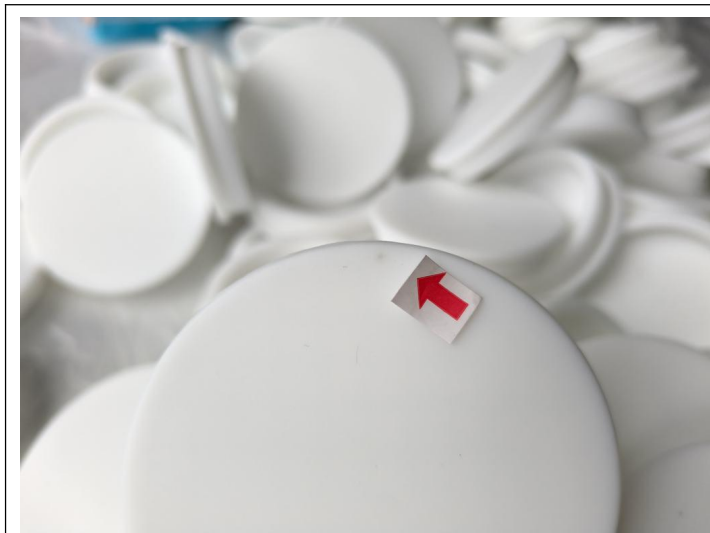
Dirty mark-minor

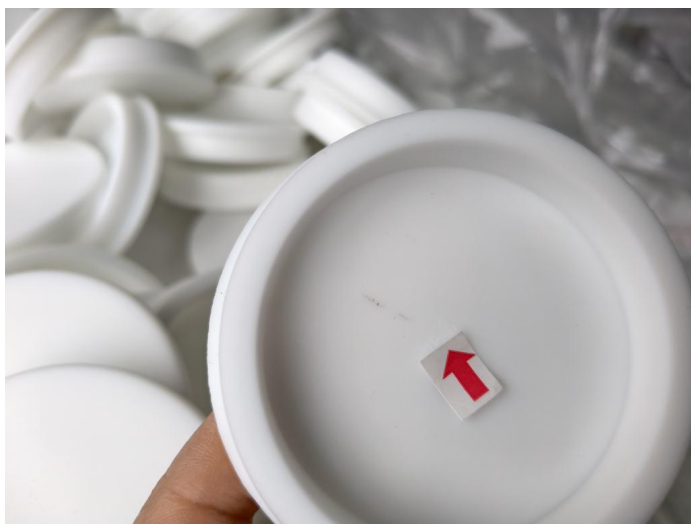
Dirty mark-minor

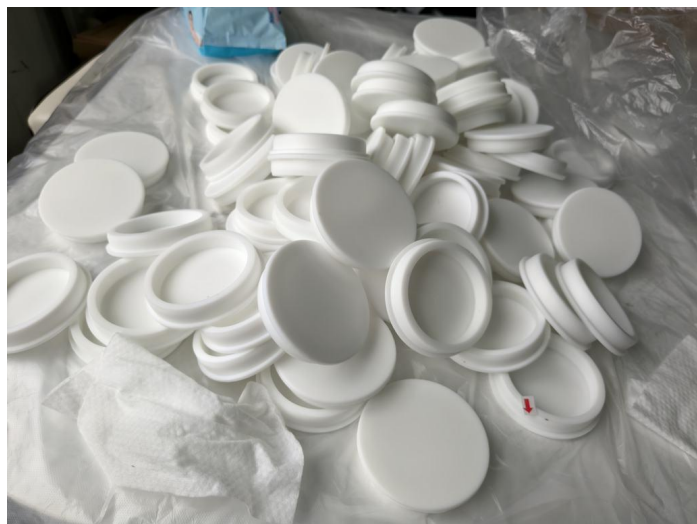
Dirty mark-minor (82pcs)

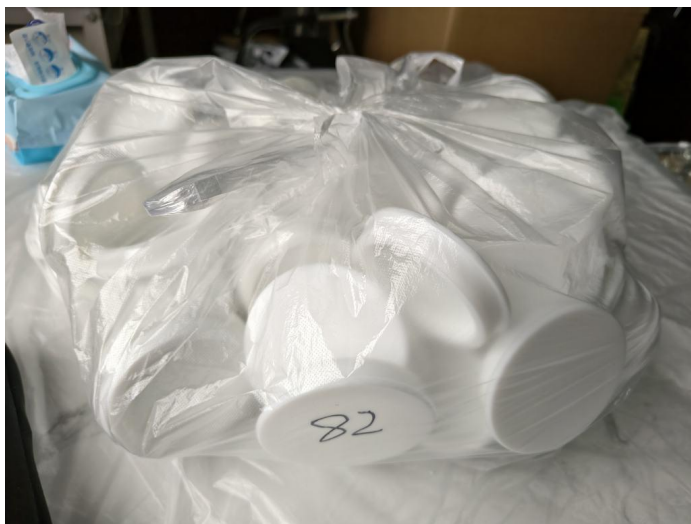
Dirty mark-minor (82pcs)
