| <b>Inspection Report</b> ( <input checked="" type="checkbox"/> 1 <sup>ST</sup> <input type="checkbox"/> 2 <sup>ND</sup> ) | | <h1>Pending</h1> | |
| <input checked="" type="checkbox"/> Pre-shipment <input type="checkbox"/> ON-LINE <input type="checkbox"/> IN PROCESS <input type="checkbox"/> FULL | | | |
| <b>Summary Section</b> | | Service Number: F-QC 20251021 | |
| | | Product Name | KIT COMPLET-DEBOUCHEUR<br>CANALISATION HAUTE PRESSION |

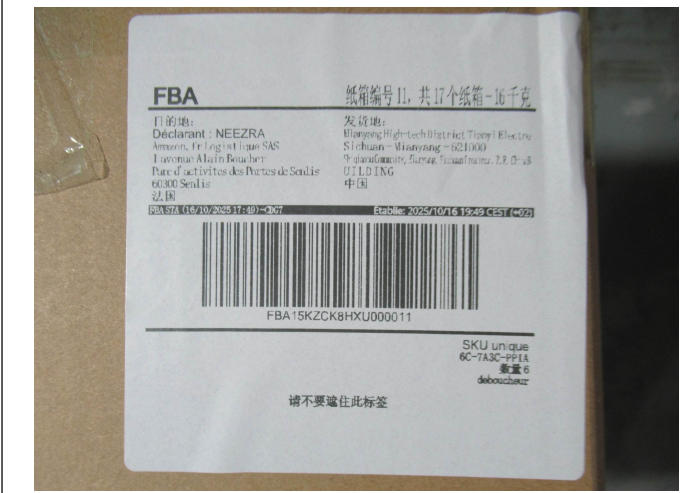
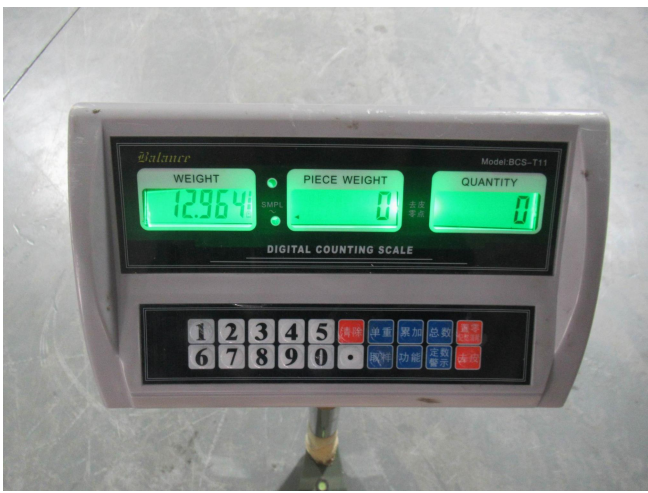
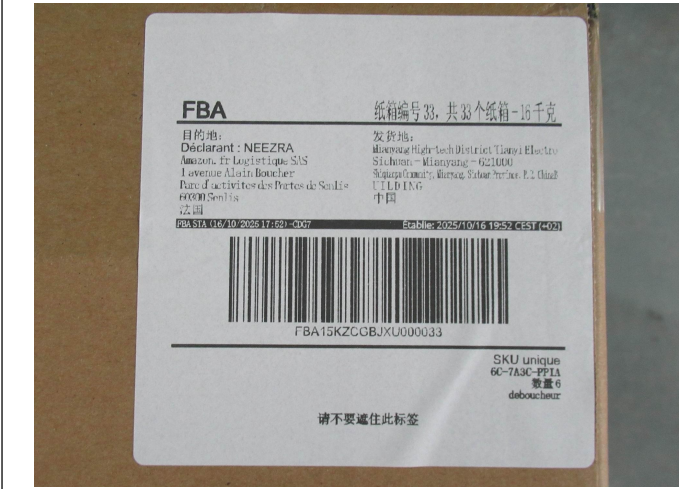
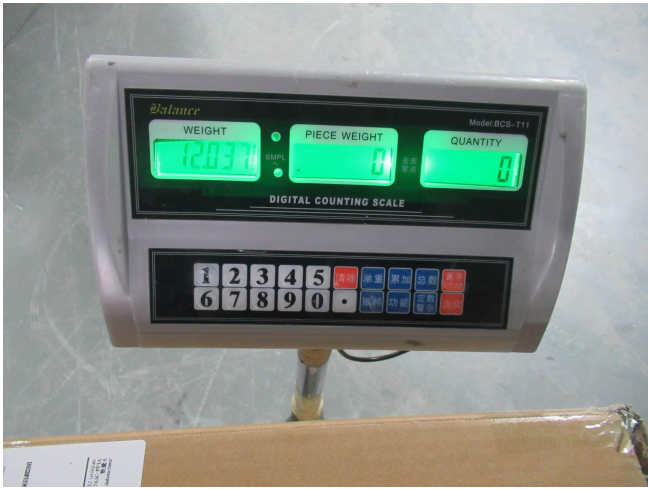
| Special Attention | |
|---|---|
| 4. | The actual weight of the outer carton deviates by more than 5% from the marked carton specifications. |

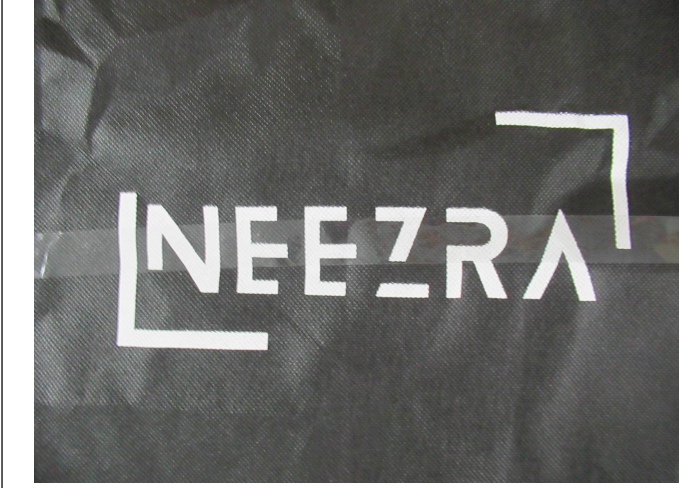
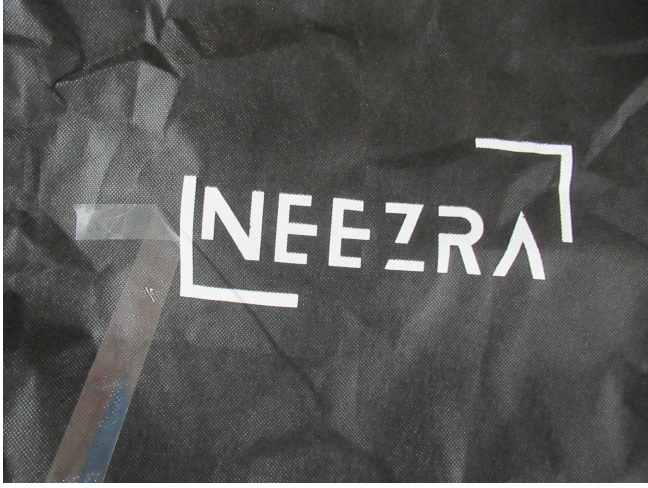
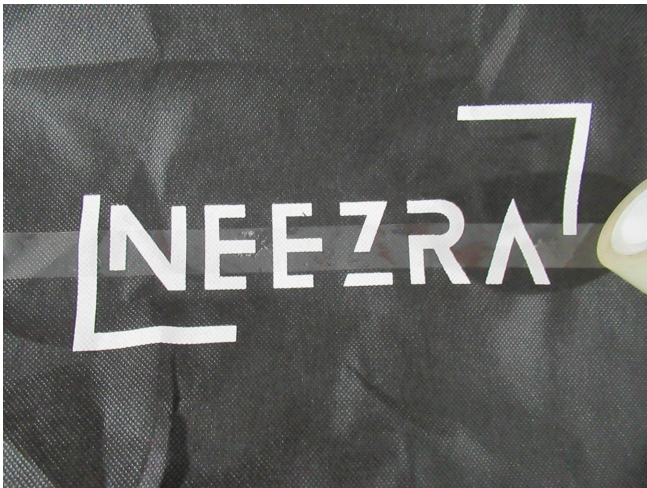
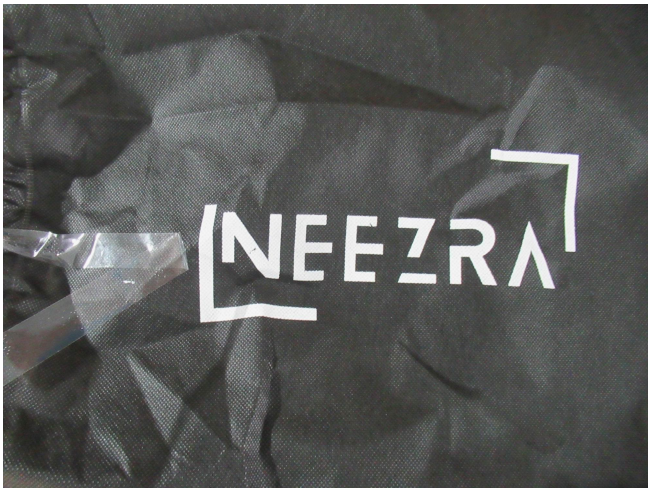
5. During the 3M tape test, it was found that the silk screen on the packaging bags of 2 pieces of black products showed signs of peeling off.

| Defective products | <input checked="" type="checkbox"/> pick out | <input type="checkbox"/> replace | <input type="checkbox"/> rework |

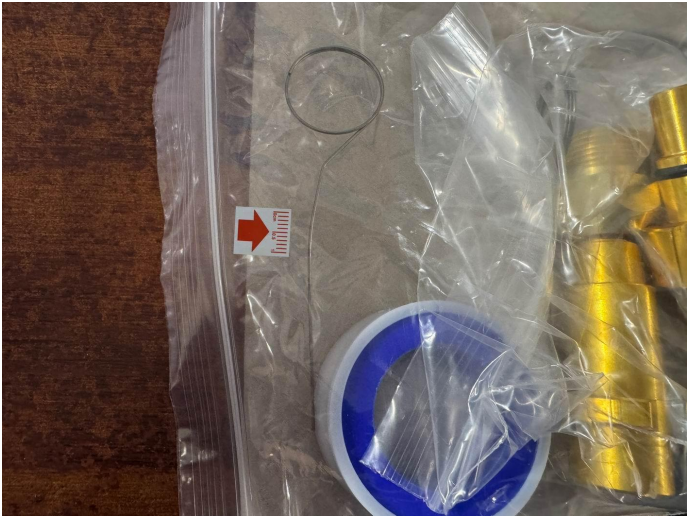
| Defectives List | | | | |
|---|---|---|---|---|
| 1. | Bending deformation mark | 0 | 1 | 0 |

| Bending deformation mark--Maj | | Broken mark--Maj | | |

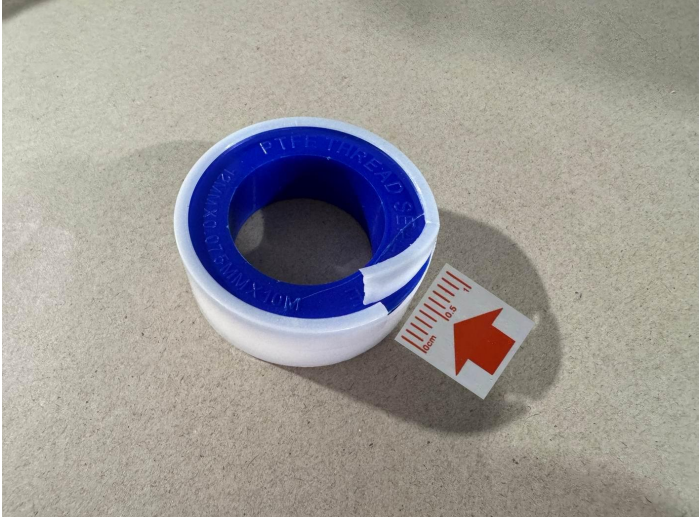
| Defectives List | | | | |
|---|---|---|---|---|
| 2. | Broken mark | 0 | 1 | 0 |

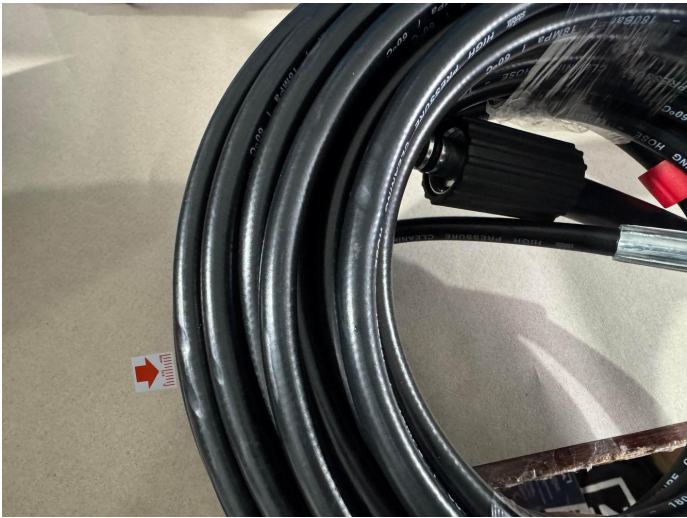
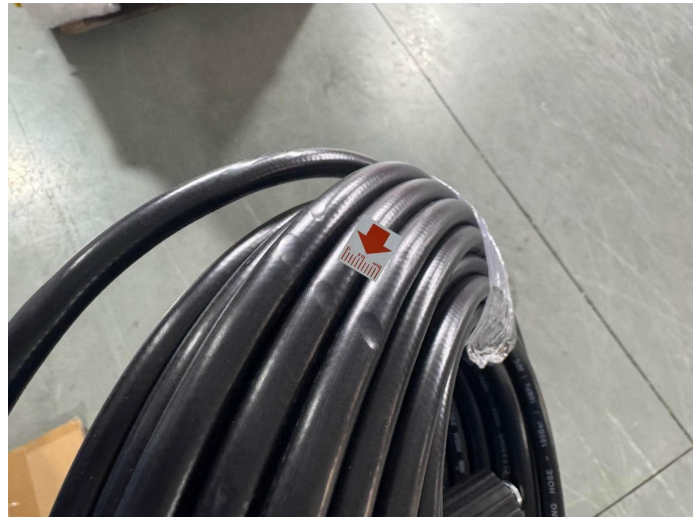
| Defectives List | | | | |
|---|---|---|---|---|
| 3. | Dent mark | 0 | 0 | 2 |

| Dent mark--Min | | Dent mark--Min | | |

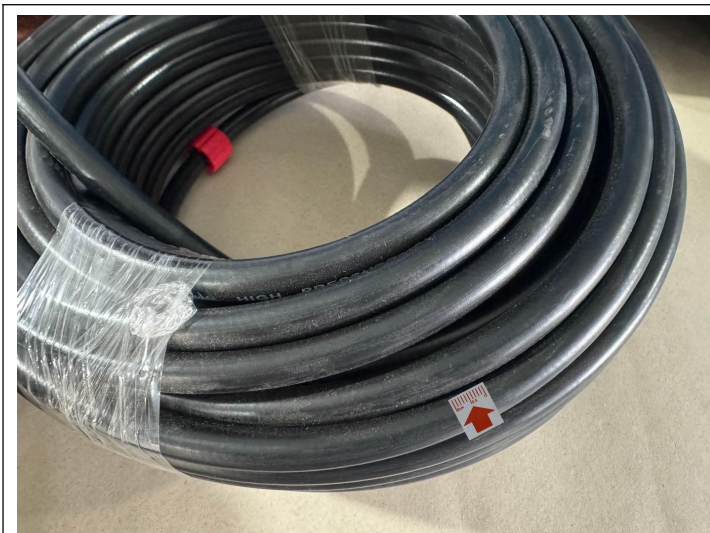
| Defectives List | | | | |
|---|---|---|---|---|
| 4. | Dirty mark | 0 | 0 | 4 |

Dirty mark--Min

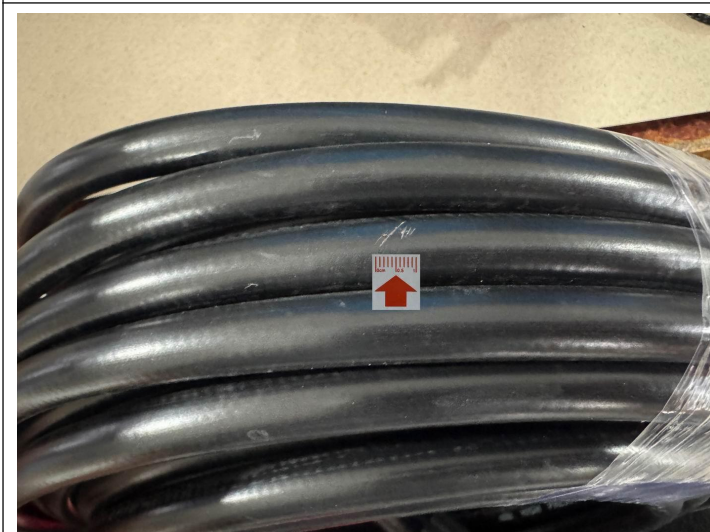
| Defectives List | | | | |
|---|---|---|---|---|
| 5. | Scratch mark | 0 | 0 | 2 |

Scratch mark--Min

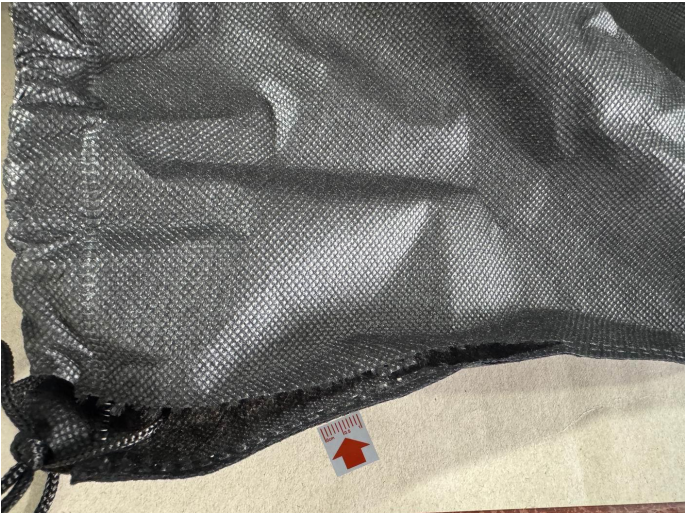
| Defectives List | | | | |
|---|---|---|---|---|
| 7. | Broken mark | 0 | 1 | 0 |

| <p>Broken mark--Maj</p> | <p>Dirty mark--Min</p> |

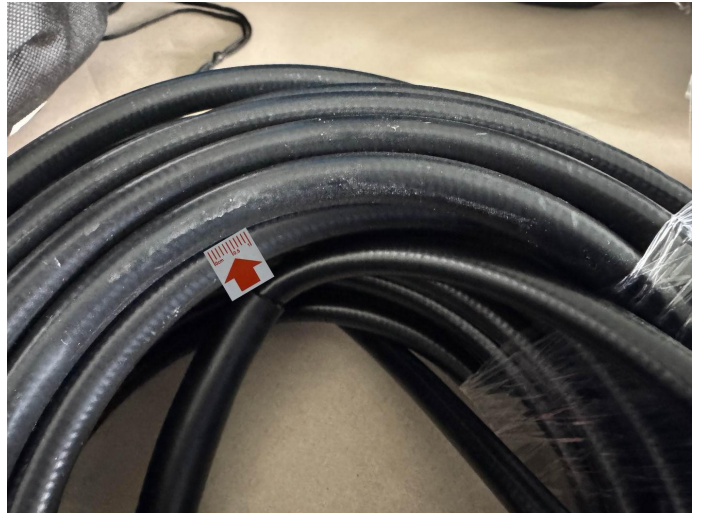
| 8. | Dirty mark | 0 | 0 | 3 |

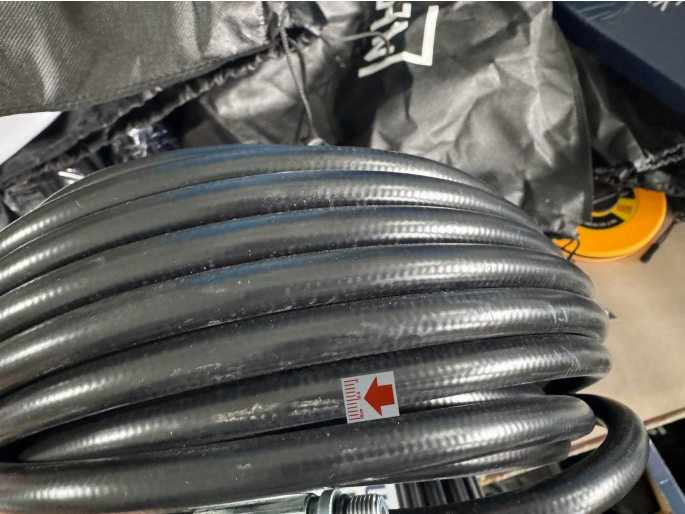
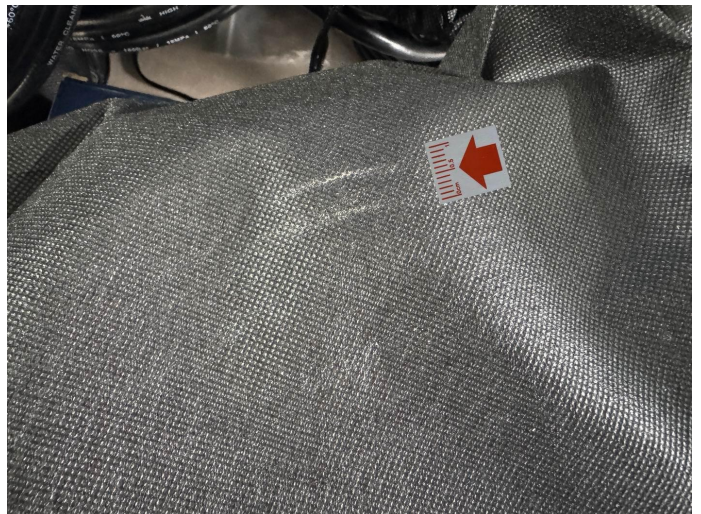
| <p>Dirty mark--Min</p> | <p>Dirty mark--Min</p> |

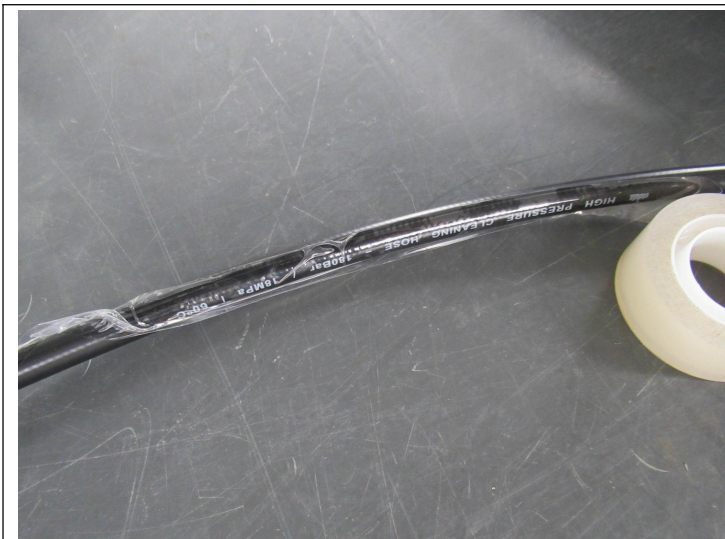
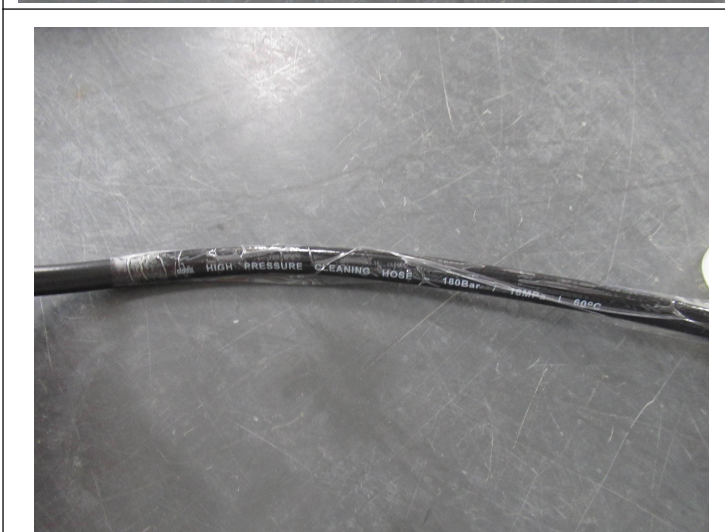
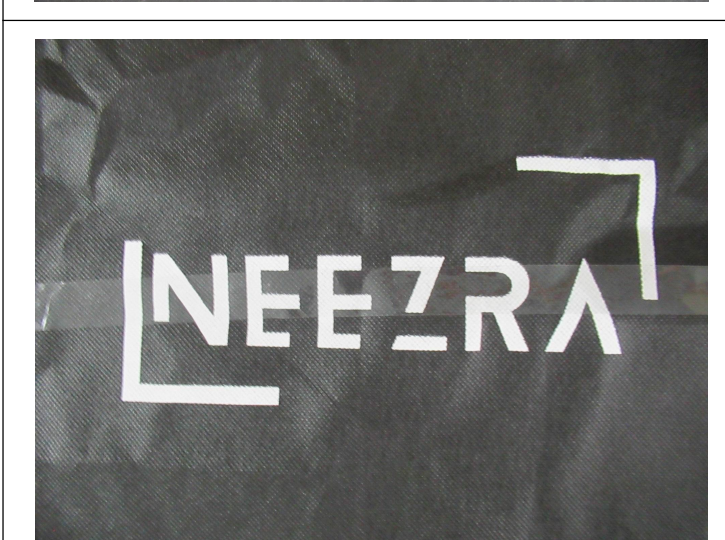
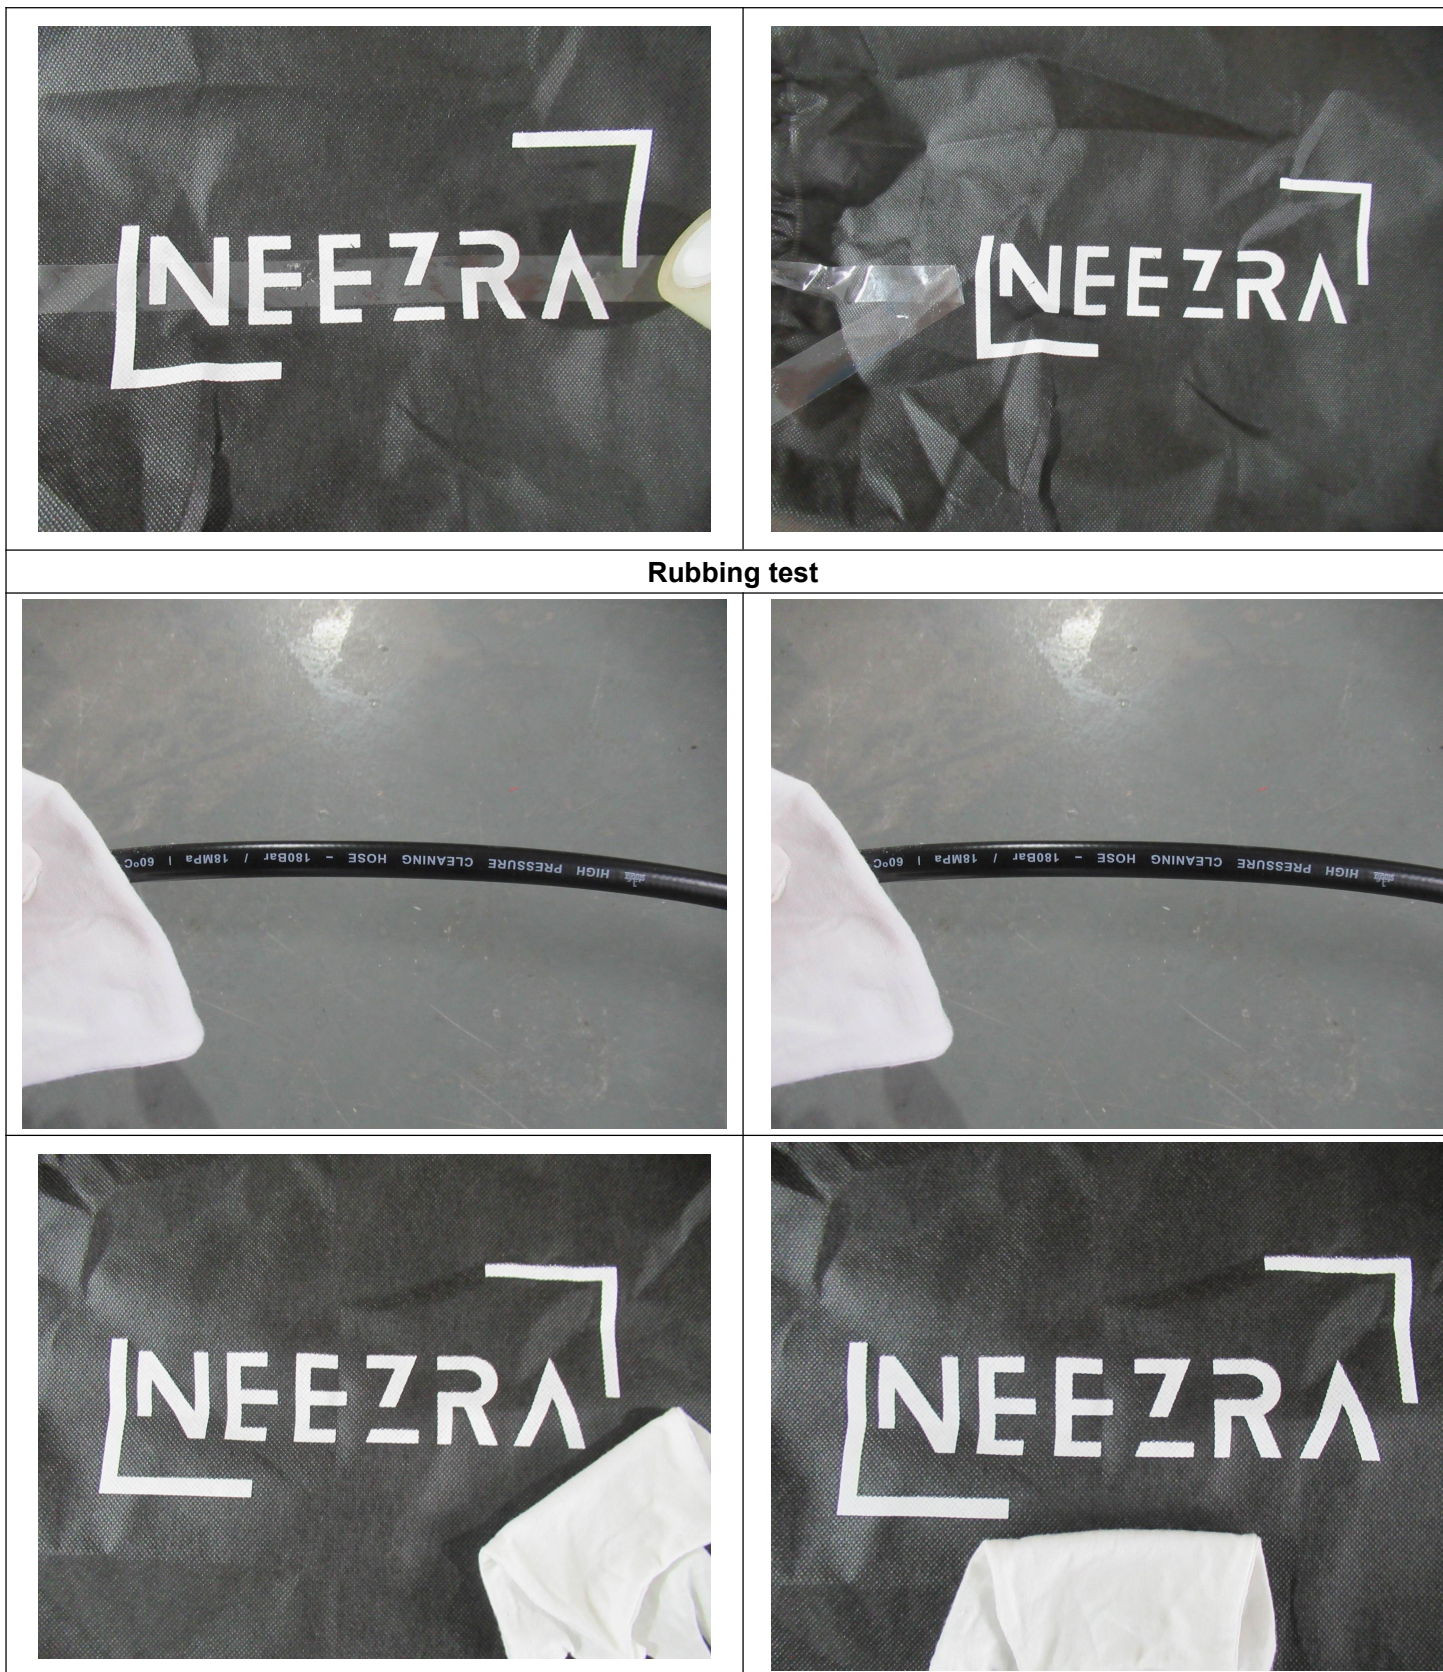
| TESTING/CHECKING | | | | | | | |
|---|---|---|---|---|---|---|---|
| 6. | Coating adhesion test on logo | S-1 | 5 | 0 | 0 | 2 | Pending |
